Aviation Safety

Ultralight and Balloon

Issue 2/2000

Analysis of Recent Incidents

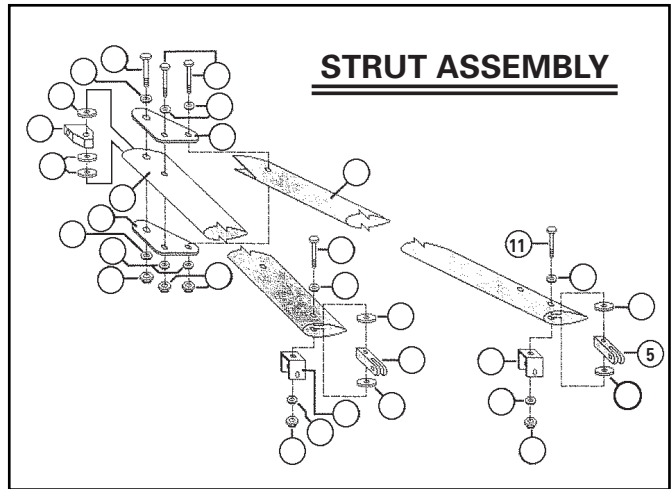
The second SeaRey accident resulted from a maintenance oversight while the owner/operator was inserting a strut bolt to hold the rear wing strut in place. The AN-17a bolt (part 11 on the diagram on p. 2) was removed to install another component and was immediately replaced. However, unnoticed by the installer, it was inserted in such a manner that it missed the hole in the main strut attachment fork (part 5 in the diagram on p. 2). As a result, the strut pulled out of the fitting and the port wing began folding immediately after takeoff as the weight of the aircraft transferred to the wings, resulting in an uncontrolled encounter with the terrain beside the runway. This type of oversight has occurred on various types of aircraft in the past (see the front page article, "Missing Bolt Fatal," in issue 2/95 and issue 1/95 "Incorrect Assembly," another article dealing with the same type of incident).

The bolt identified as part 11 was inserted inadvertently missing the hole in part 5, which was vital if the rear wing strut were to be held securely. Instead, the bolt went beside part 5, allowing part 5 to pull out of the strut when the weight of the aircraft becoming airborne was transferred from the wheels to the wings, thus allowing the left wing to fold.

How can this type of oversight be eliminated? If working alone, as is often the case where small aircraft are concerned, the whole job must be reinspected by the owner or preferably another knowledgeable person prior to flight. In other words, completely double-check your own work against existing manuals and procedures to ensure correctness before attempting flight after maintenance. There are no regulations governing ultralight or advanced ultralight maintenance, so the aircraft owner must get it right. Double-checking maintenance is standard practice in the aviation industry where supervisors regularly inspect the work of subordinates. With the introduction of "owner maintenance" in the general aviation industry, it will become more important for owners to realize that it is a safety benefit to have work reinspected or double-checked. Unfortunately most ultralight owners and amateur-builders work alone, a practice that can set up a situation for a maintenance accident. —Ed.

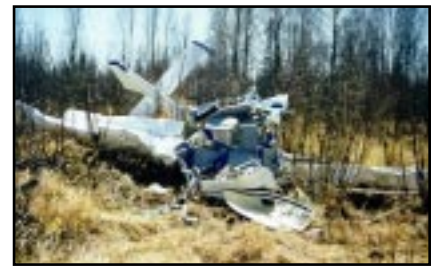
During the investigation of a fatal accident involving a **Storm** amateur-built aircraft, the following observations were made on the construction method, particularly the use of pop rivets in the thin skin. In this case radar tape showed the aircraft descending at 200 fpm for 1.5 min near the point where it struck the ground for undetermined reasons.

The Storm accident scene.

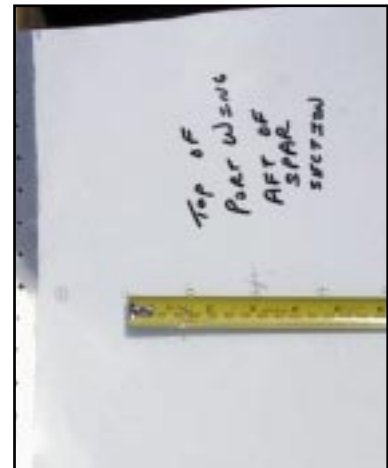
The TSB investigator at the scene noted that the aircraft skins were assembled with aluminum pop rivets. When the two skins were pulled apart by hand, the rivet holes in the thin skin did not deform. Several aluminum rivet heads that had popped as a result of the accident were found in the engine and propeller spinner area. The manufacturer of the kit supplies the purchaser with aluminum rivets for assembly.

While the aircraft showed no signs of in-flight breakup, closer examination of the construction techniques raised some safety concerns, specifically with the riveting. Laboratory analysis of the rivets used in the aircraft confirmed they were of the proper material composition. One alarming observation was the fact that skins on the ribs as recovered from the crashed aircraft could easily be pulled off, somewhat like a zipper, as the

rivet heads pulled through the holes in the metal sheeting. People who specialize in amateur-built and ultralight aircraft also made some interesting points about the rivets. In some places the space between the rivets appeared excessive and measured as much as 1.5 in. None of the wing skin samples showed signs of deburring and, in some cases, the rivets used were too short. All these factors led to the aircraft coming apart on impact in an unusual way. The skins separated along the rivet lines, as previously mentioned, like a zipper, with no distortion of the rivet holes, and the majority of the rivets failed in shear. None of the .020 aluminum skins were ripped even though the impact forces were well over 50 g. It was the opinion of several industry people that the aircraft was bound to experience a structural failure eventually because of the riveting job done during construction. The aircraft had approximately 50 hr. on the airframe at the time of the accident.

Skin from crashed aircraft illustrating rivet spacing and holes where rivets pulled through.

This information is published with the safety observation for aircraft builders working with thin dimpled skins and pop rivets to verify their work against accepted industry standards. Although it may be

an extra cost, in some cases of newly marketed kits it may be prudent to have the kit checked by a professional aircraft structure technician before purchasing it and then follow the advice obtained, particularly on the matter of rivet spacing, when assembling the kit. ✈️
